**CLEAN WATER ACT COMPLIANCE INSPECTION
U.S. ENVIRONMENTAL PROTECTION AGENCY, REGION 5**

Legend Farms Dairy, LLC

Date of Inspection: April 20, 2017 - April 21, 2017

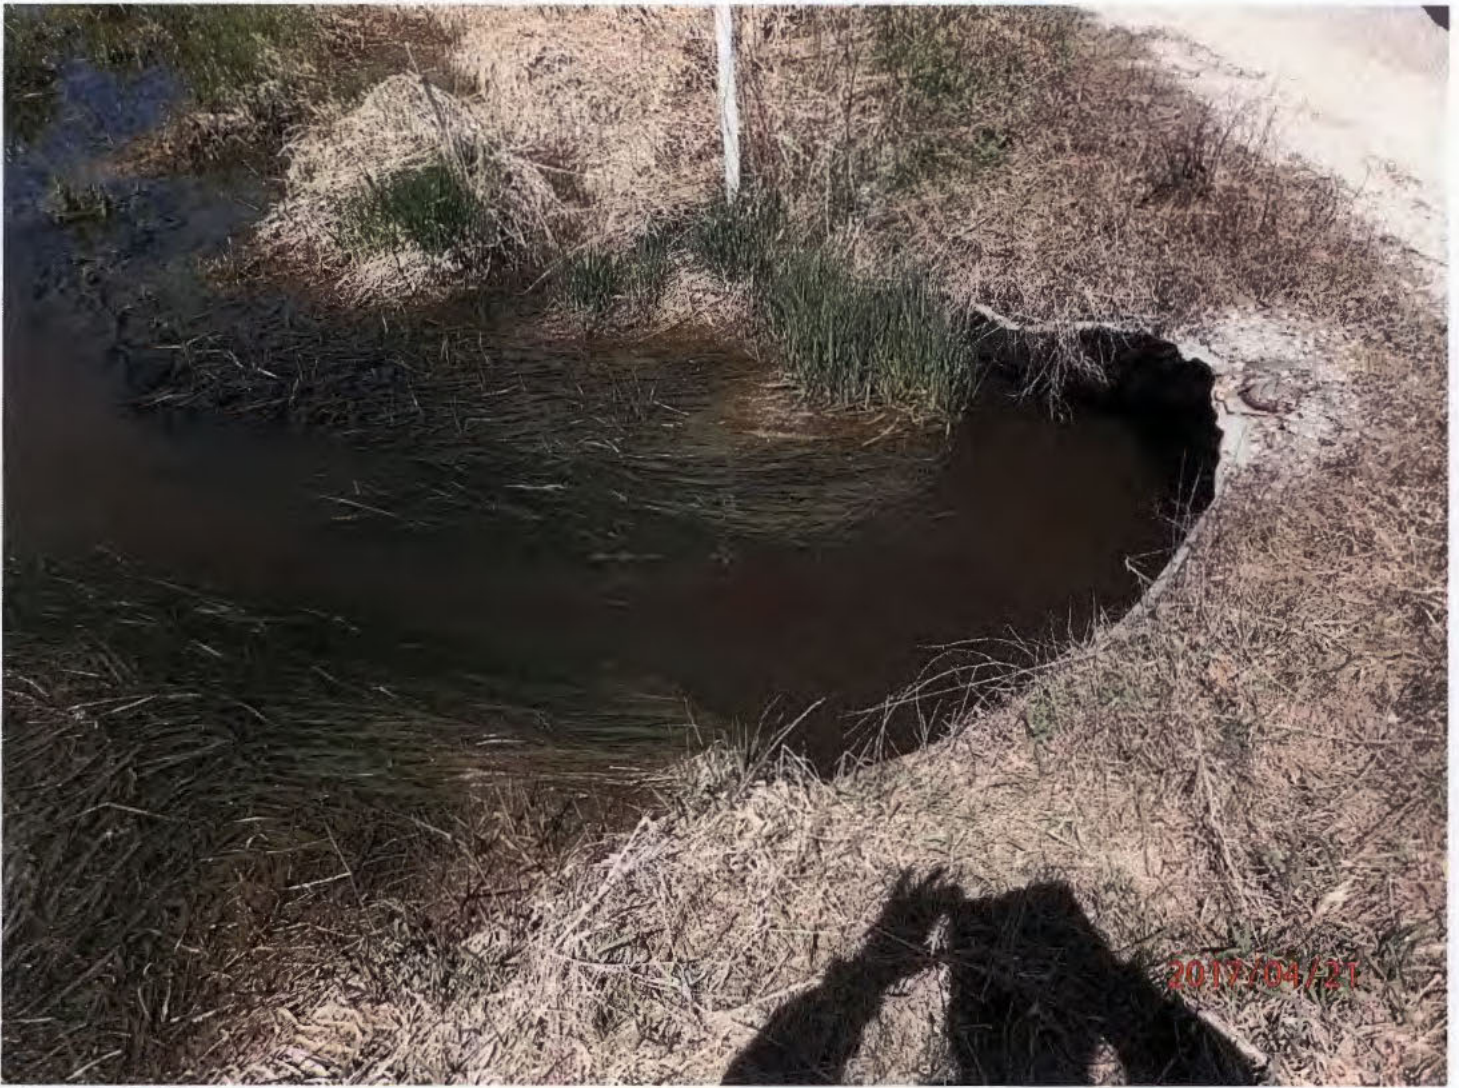
Photo: P4210134

Description: EPA observed flow through the culvert outlet on the west side of County Road B.

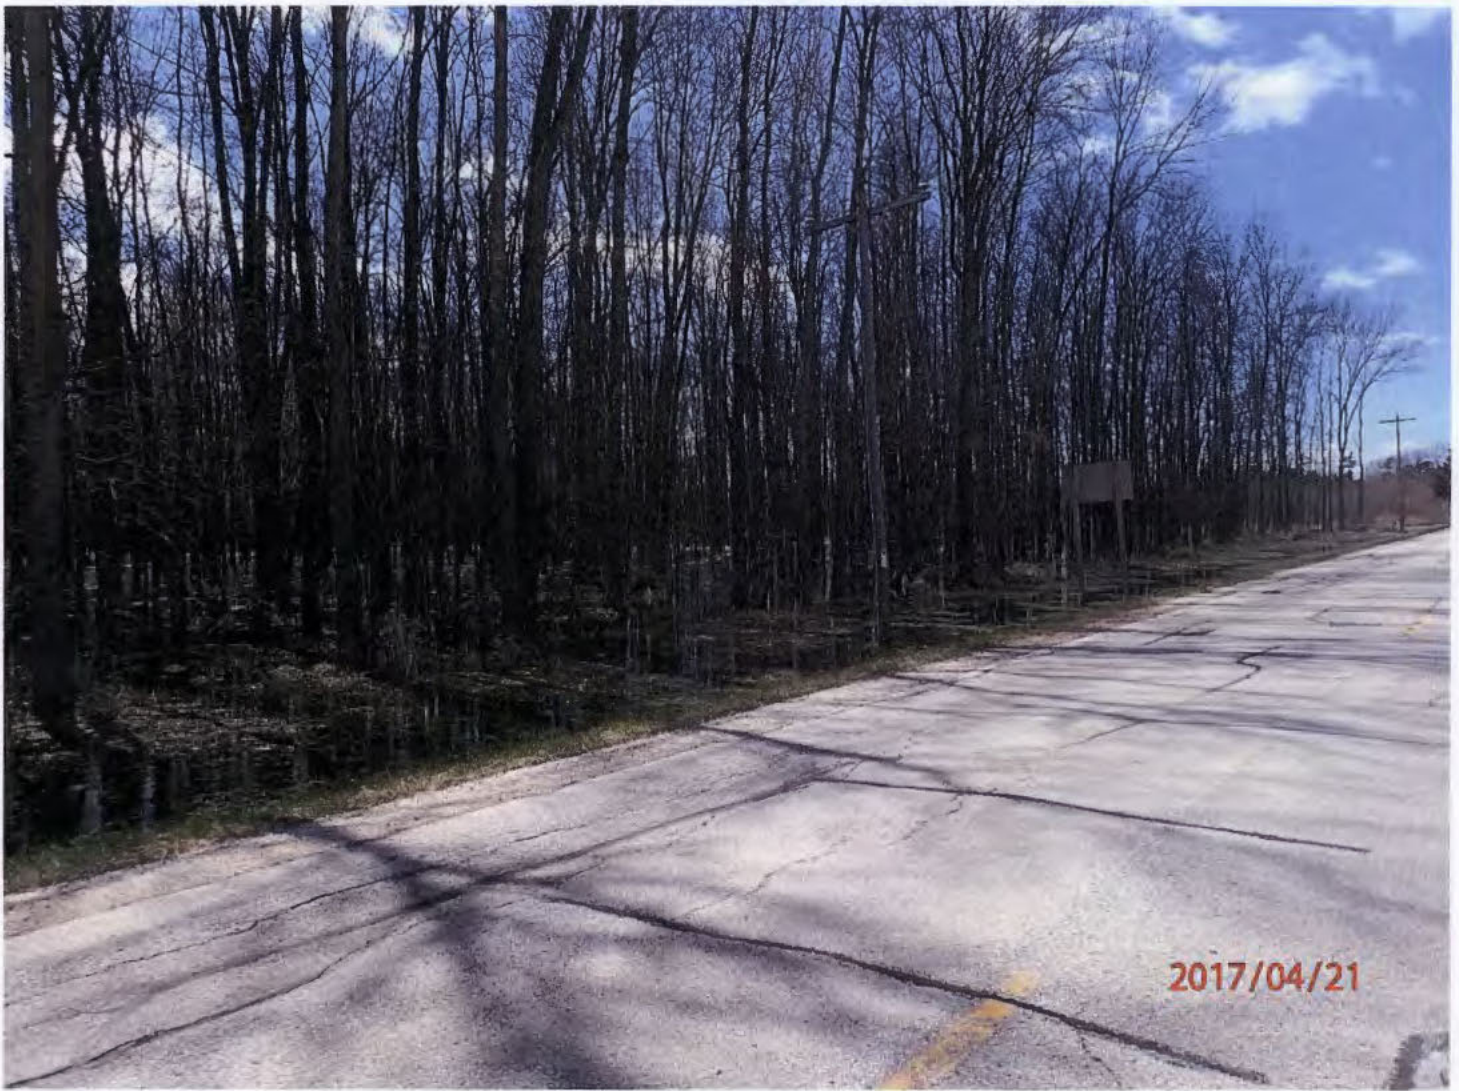
Photo: P4210135

Description: EPA observed the continued flow from the tile outlet west along the south side of County Road F into wetland area.

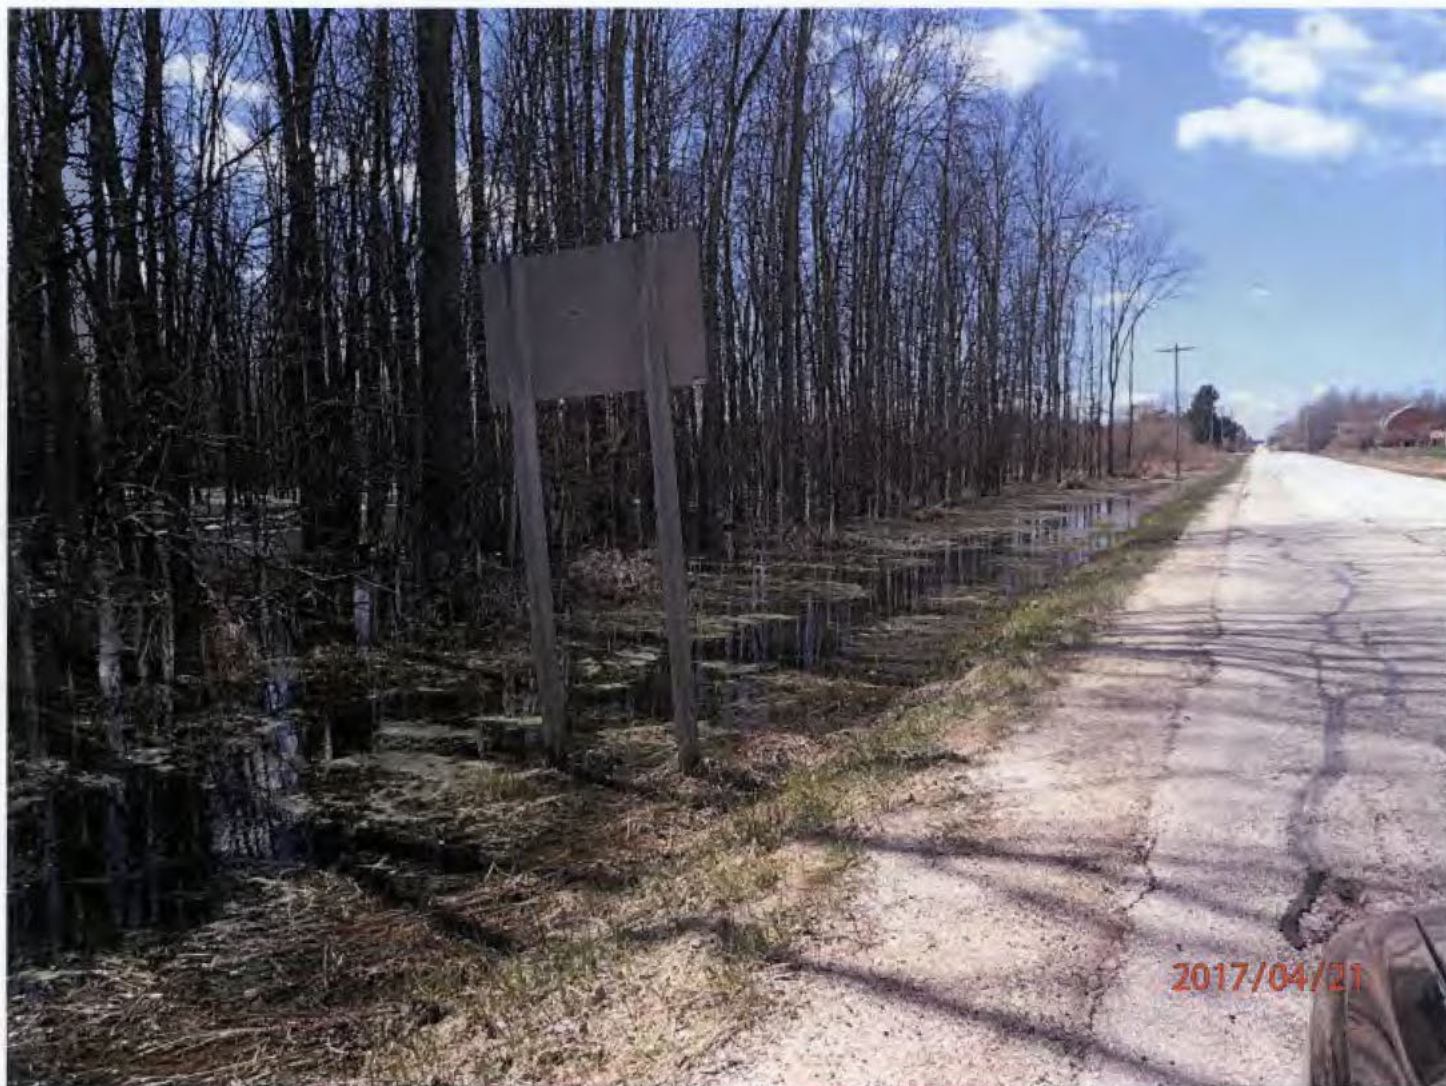
Photo: P4210136

Description: EPA observed the continued flow along the south side of County Road F as it continued to flow west.

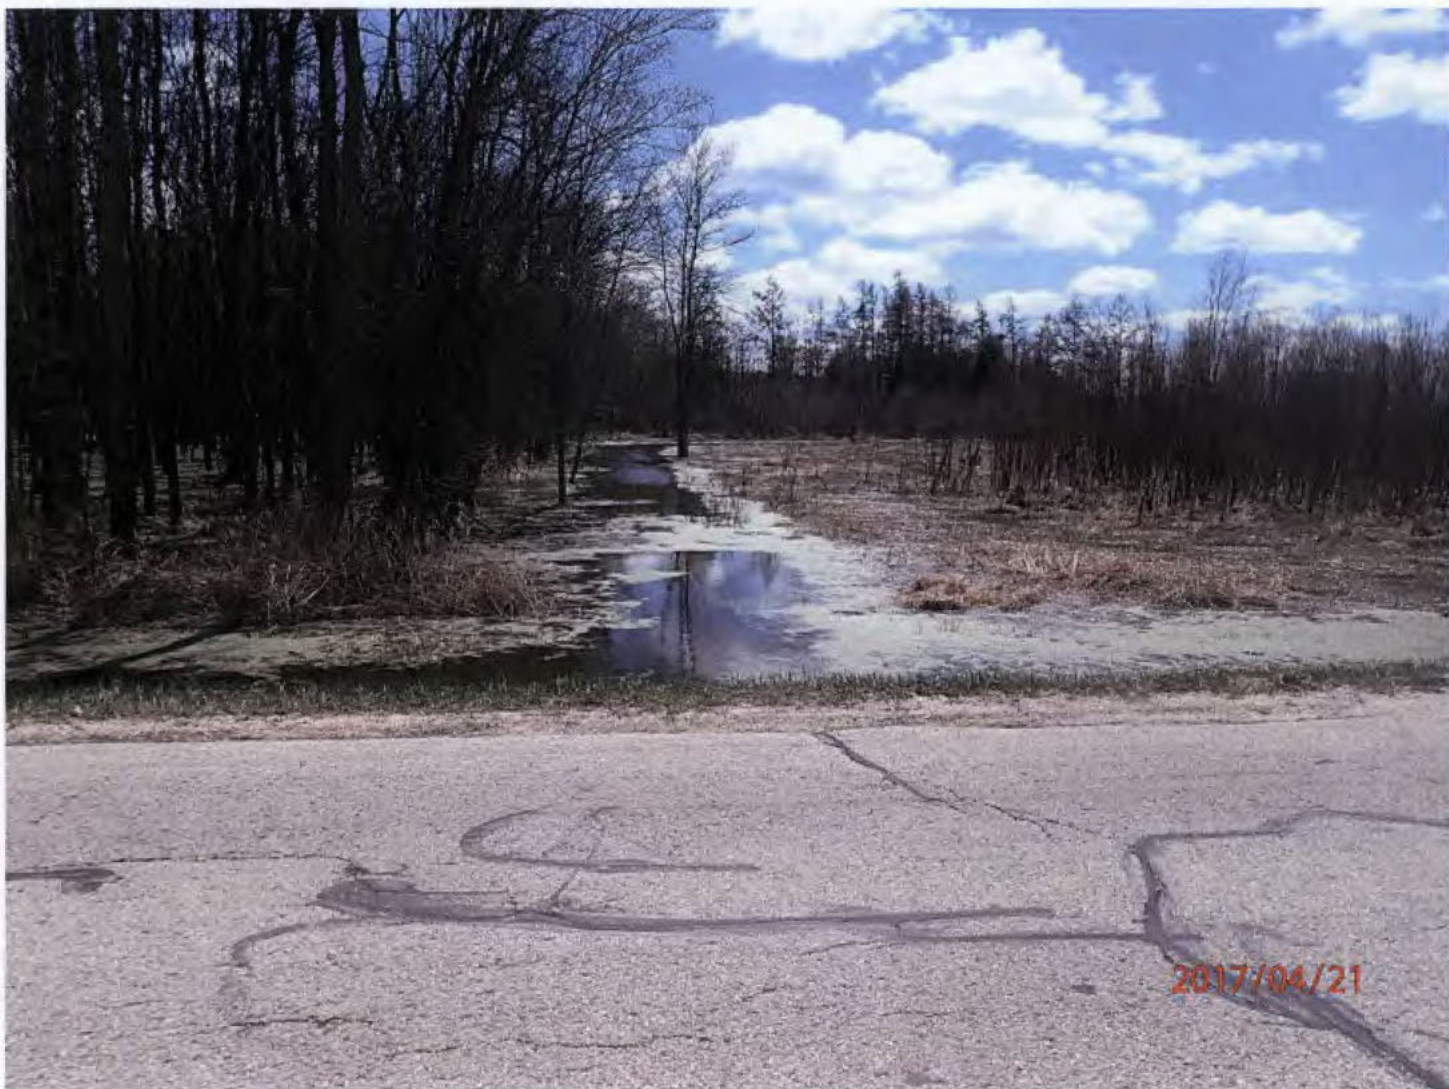
Photo: P4210137

Description: EPA observed the water from the tile outlet flowing west within the roadside ditch on the south side of County Road F flowing into an unnamed tributary and flowing south.

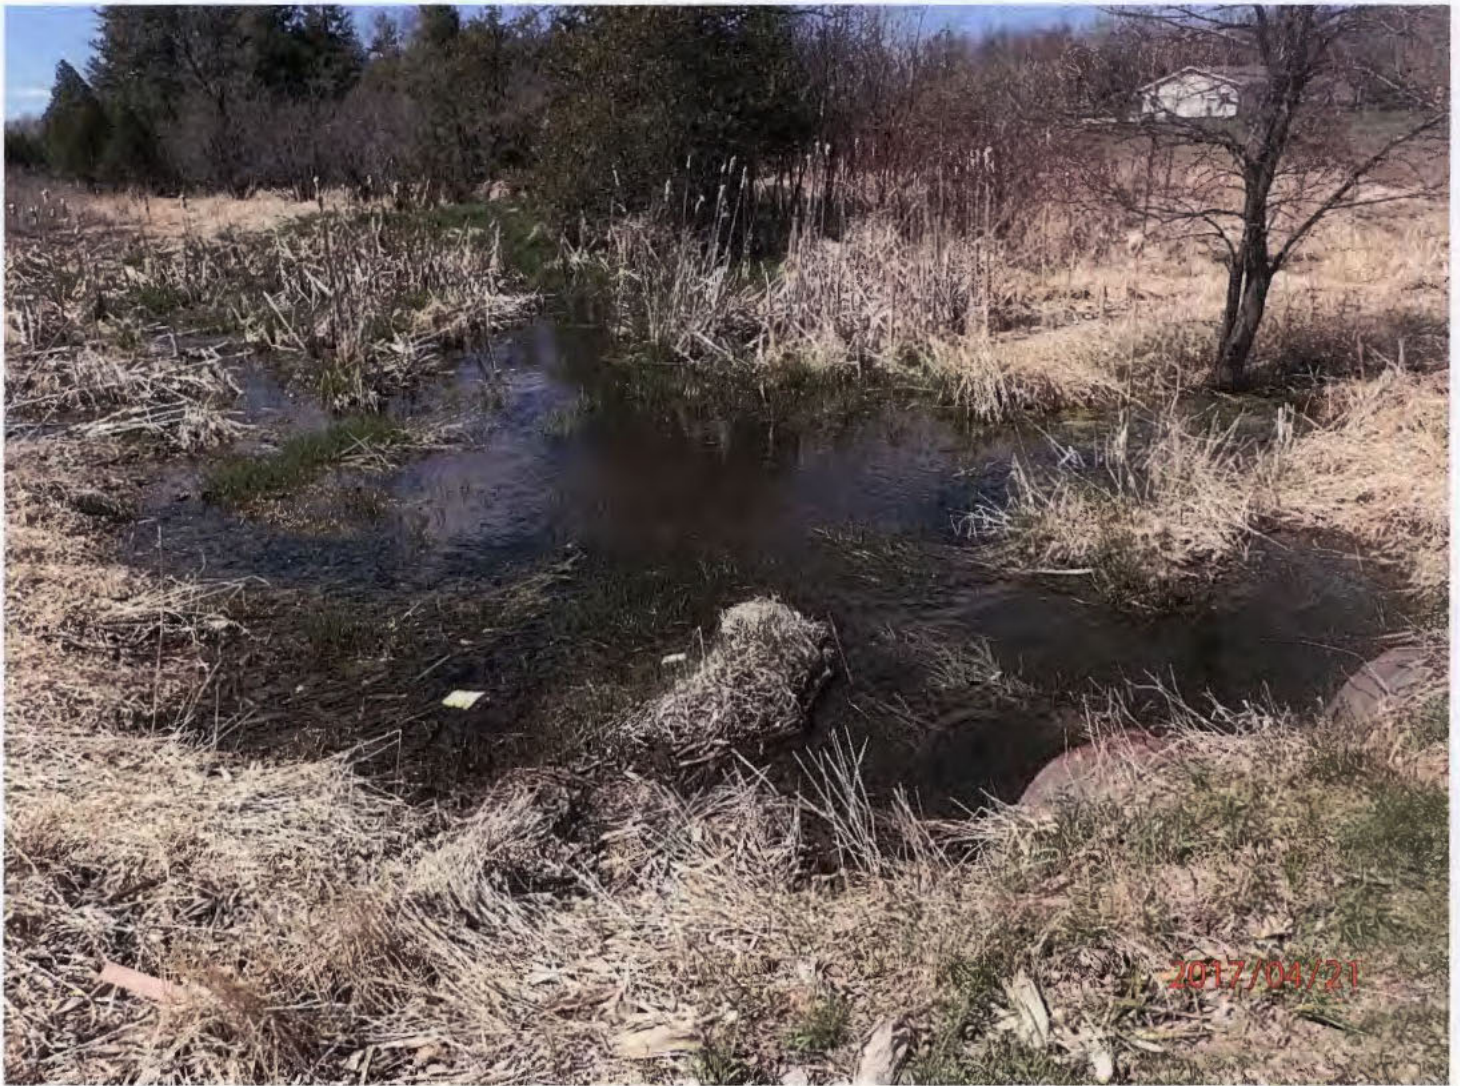
Photo: P4210143

Description: EPA documenting downstream flow of unnamed tributary documenting the continued flow from the tile outlet to a water of the United States.

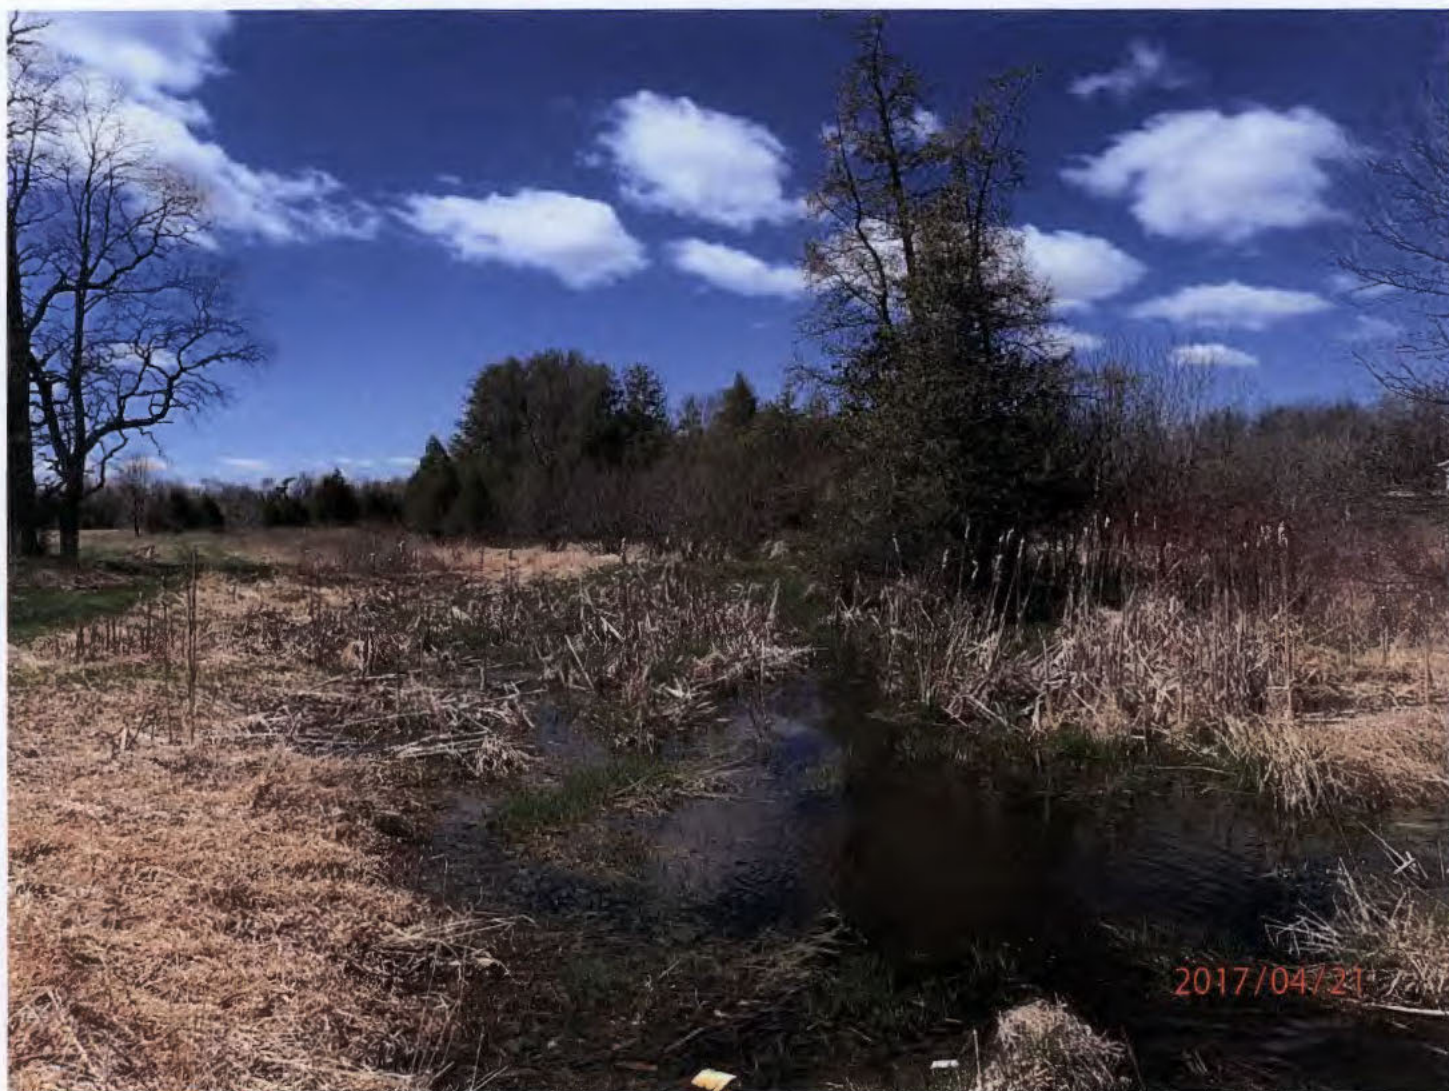
Photo: P4210144

Description: EPA documenting flow from the County Road F into unnamed tributary looking downstream.

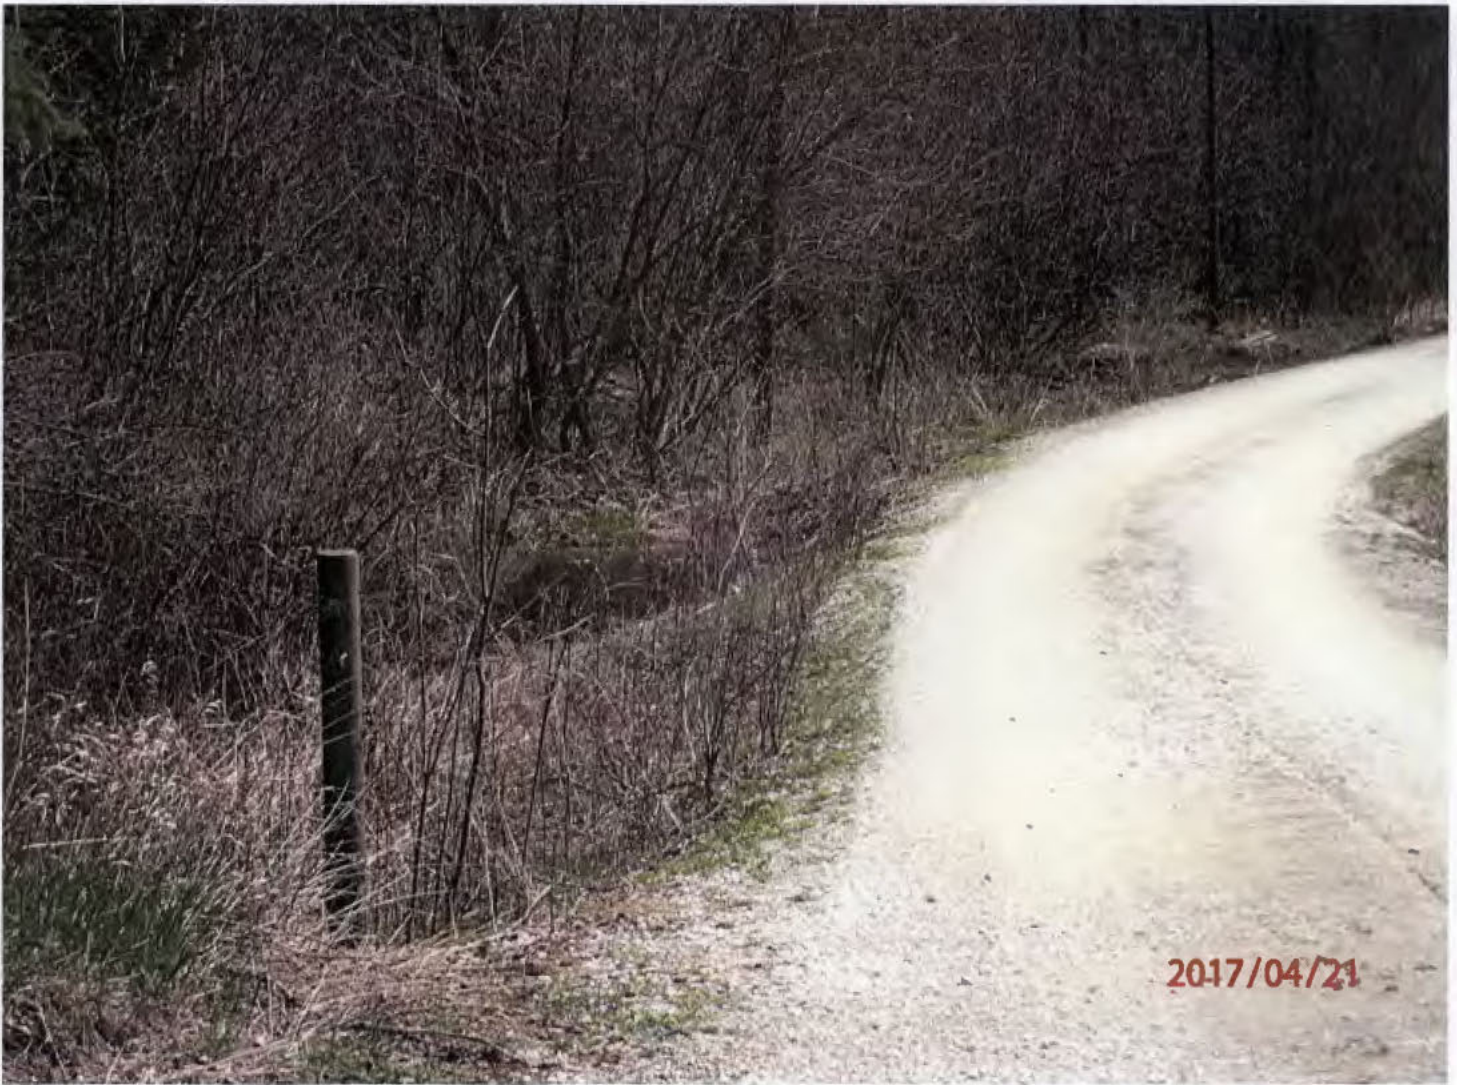
Photo: P4210145

Description: EPA to continue to document flow in Krok Creek. EPA drove down a road to a campground off of County Road F. EPA documented that there was flow within the Krok Creek.

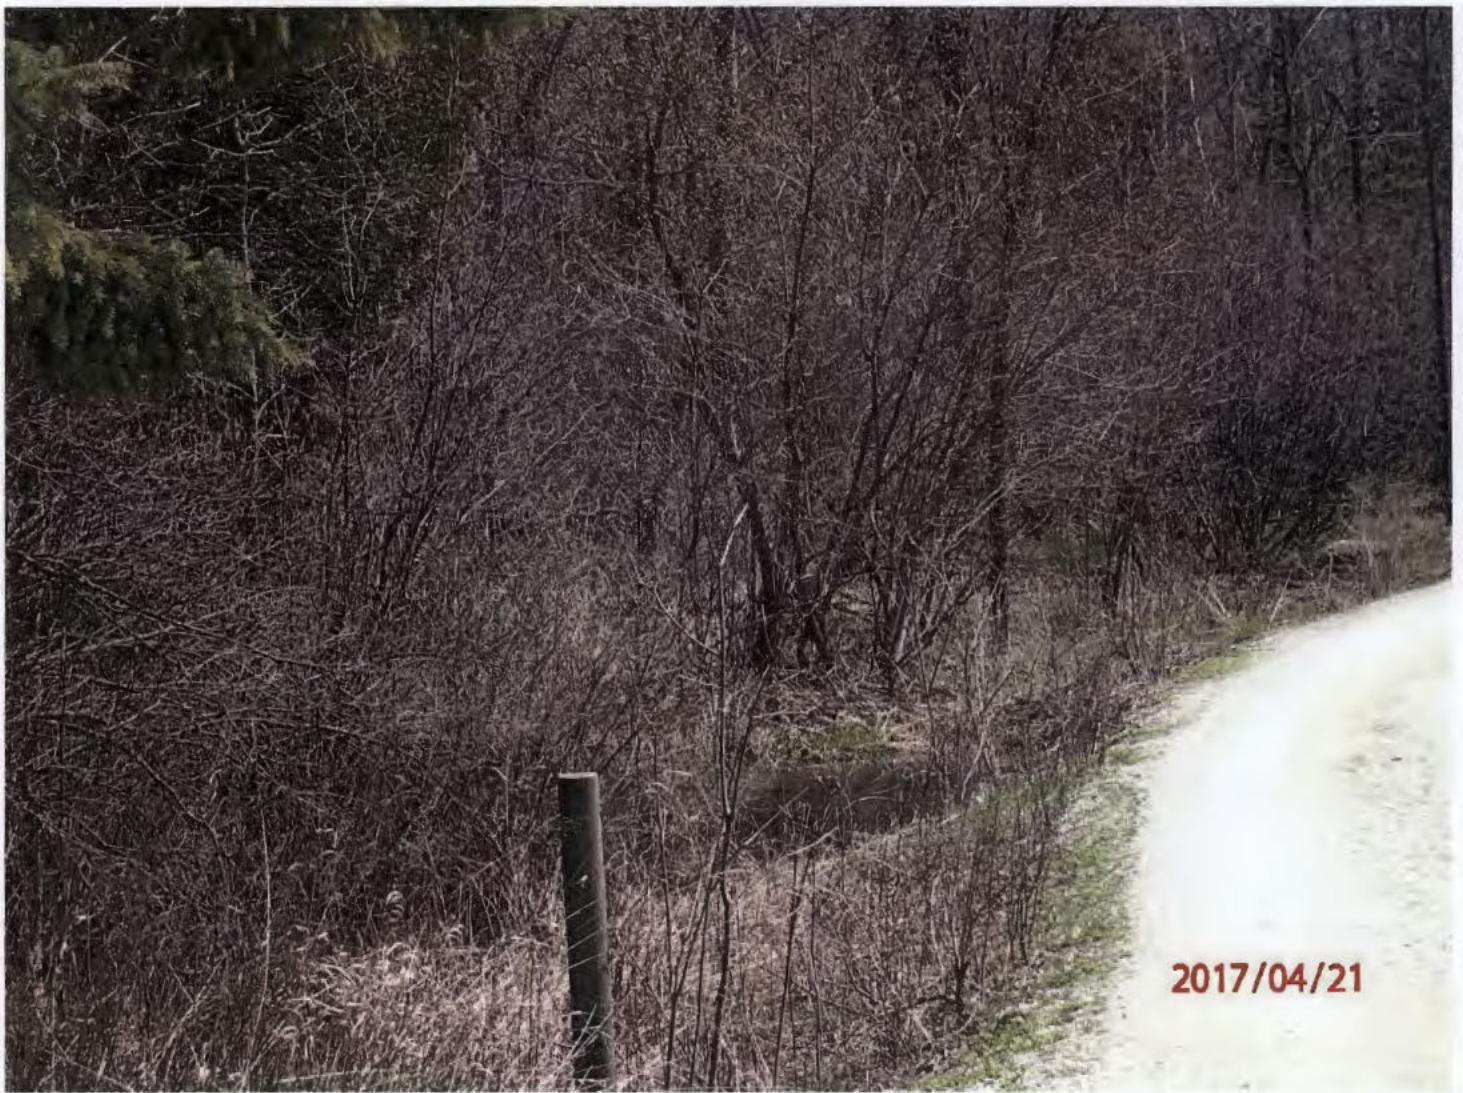
Photo: P4210148

Description: EPA observing the upstream flow of Krok Creek.
